Original Research Paper

# Exploratory Study on the Fracture Resistance of Cast Glass

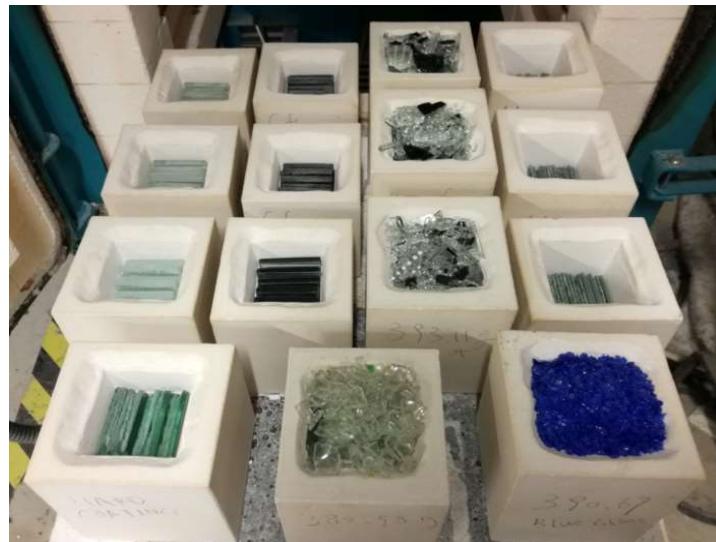
**Fig. 1:** Arrangement of glass cullet in disposable silica plaster moulds
